SERVICE BULLETIN

Super Raven Dash-M Series

TITLE: LINE ATTACHMENT STRUCTURAL ENHANCEMENT

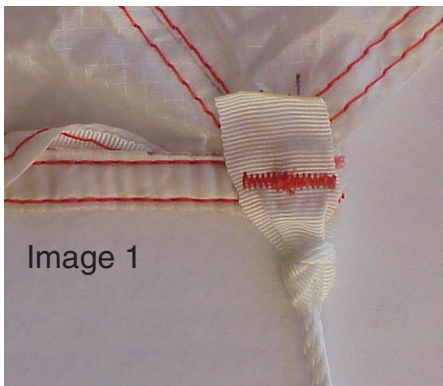
Image 1

Affected canopies have serial numbers whose last 5 digits are below 35937 and can be further identified by the single 42 stitch bartack in the .75" T-III MIL-T-5038 tape line attachment loops (Image 1).

Image 1: Affected canopies have a single 42 stitch bartack pattern in .75 inch T-III tape loop

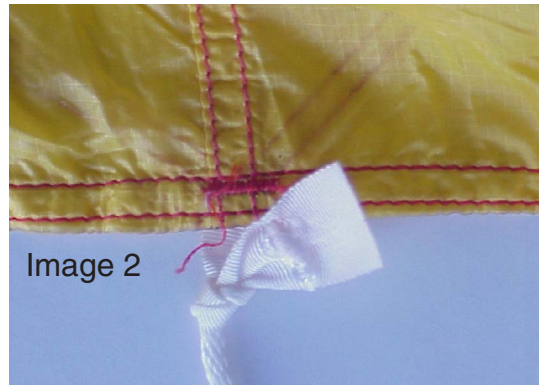
Image 2

Exceptionally hard opening shocks generated by the subject canopies have prompted this Service Bulletin. Forces generated during opening shock resulted in a cataclysmic compromise of the line attachment system, with collateral damage extending upward generating torn canopy fabric and downward generating broken lines. The initial point of failure appeared to be similar in both cases, beginning in the region of the off-center A line attachment point. Subsequently, transient loading migrated outward and rearward affecting the integrity of some of the adjacent line attachment loops.

The failure mode was in the destruction of the .75 x T-III MIL T-5038 line attachment loop tape, manifested by pulling the attachment loop tape away from the canopy but leaving the associated stitching intact (image 2).

Image 2: Damage at one of the 'B' line attachment points

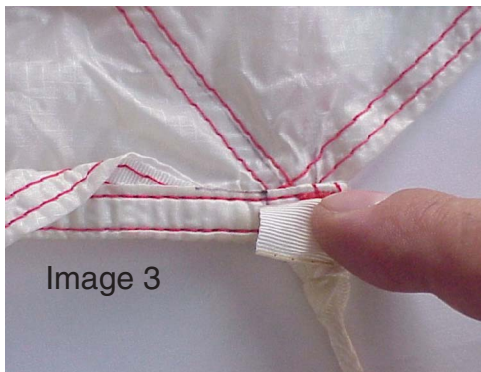
Image 3

Image 3: Pulling back the line attachment loop reveals the 28 stitch tack in the leading edge.
